PENNSYLVANIA
**W. H. WALKER DAM-
MOUNTAIN LAKE RESERVOIR**

NDS ID NO. PA-00325

PHASE I INSPECTION REPORT
NATIONAL DAM INSPECTION PROGRAM

L. ROBERT KIMBALL and ASSOCIATES
CONSULTING ENGINEERS and ARCHITECTS
EBENSBURG, PENNSYLVANIA
15931

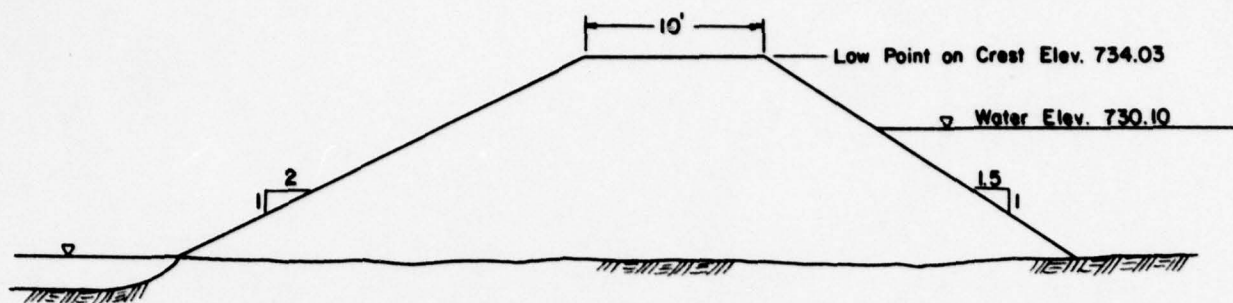
SECTION A-A
EMBANKMENT SECTION

The earth embankment is in poor condition and is in need of maintenance and repair. The concrete spillway and abandoned powerhouse are deteriorating. No stability analyses have been conducted on the gravity or embankment sections. A stability analysis was conducted for this study using assumed parameters and a water level corresponding to 50% PMF indicated structural instability.

3. All gullies, erosion, ruts, and low points on the embankment should be repaired.

5. Riprap should be repaired and new riprap placed on the upstream slope where none exists.

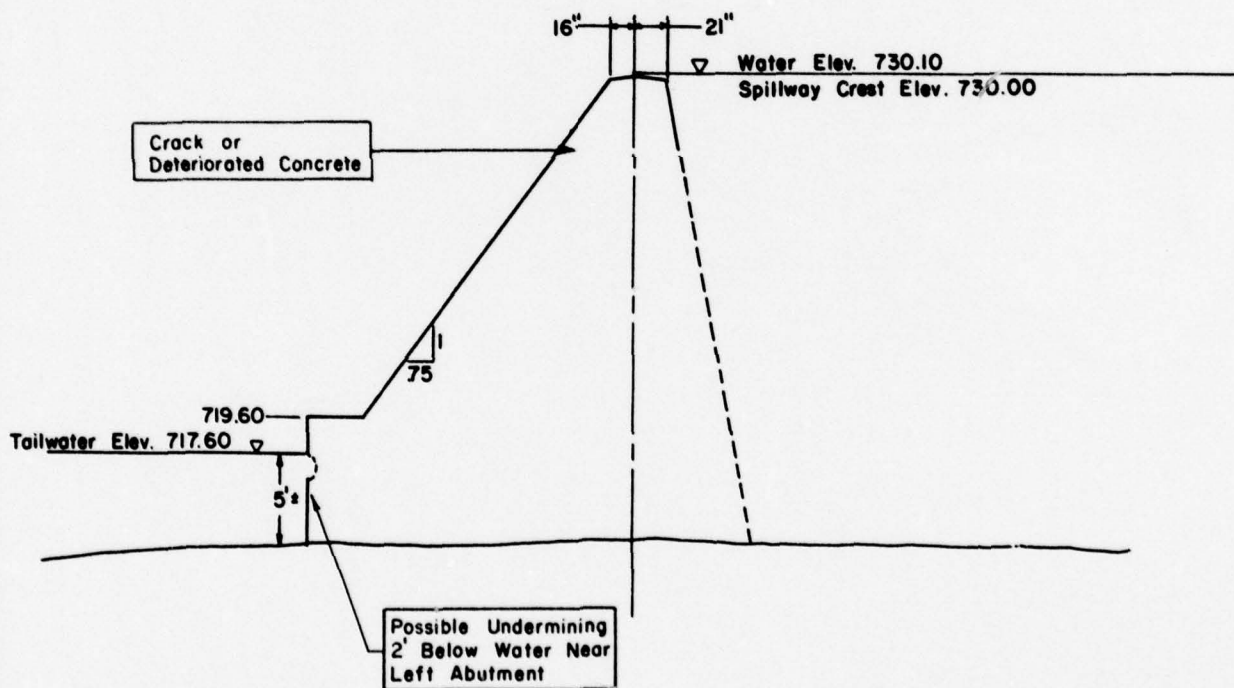
SECTION B-B
SPILLWAY SECTION

For this dam it will not be sufficient to merely increase spillway capacity. The present spillway structure is not adequate either hydraulically or structurally to pass the spillway design flood (50% PMF) for this size dam. The combination of the inadequate spillway, the questionable structural adequacy of the spillway section and the potential for the embankment to be overtopped by storms in excess of 9% PMF dictate that this structure be classified as unsafe non-emergency.

c. Appurtenant Structures. During the inspection approximately 0.1 foot of water was flowing over the spillway, making examination of the crest impossible. Near the center portion of the spillway a horizontal crack or deterioration of the concrete was noted. Close examination of this feature was not possible. During Hurricane Agnes in 1972, it was reported that the sand bar beyond the plunge pool was deposited. In addition, it appears that some undermining of the spillway toe may have occurred. The level of the tailwater did not permit examination of this feature. Considerable deterioration of the left concrete abutment with the powerhouse has taken place.

8. The crack or deterioration in the emergency spillway should be investigated. Deterioration of the concrete in the spillway and abutments should be repaired.

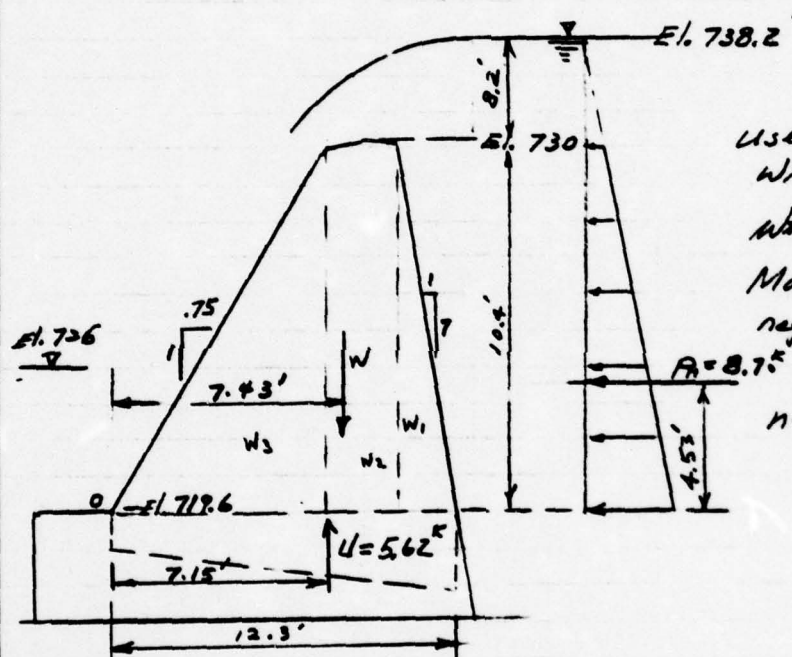
Overflow Spillway

Max. Water El. 738.2' at 0.5 PMF

Use
Wt. of Concrete, $150 \frac{\text{lb}}{\text{ft}^3}$
Wt. of Water, $62.4 \frac{\text{lb}}{\text{ft}^3}$
Max. Tailwater El. 726.0'
neglect silt effect.

neglect the arch effect.
